TRANSPORTATION RESEARCH CENTER

ON-SITE AIR BAG INVESTIGATION

CASE NO. - 94-09

**U.S. Department of Transportation
National Highway Traffic Safety Administration
National Center for Statistics and Analysis
Washington, D.C. 20590**

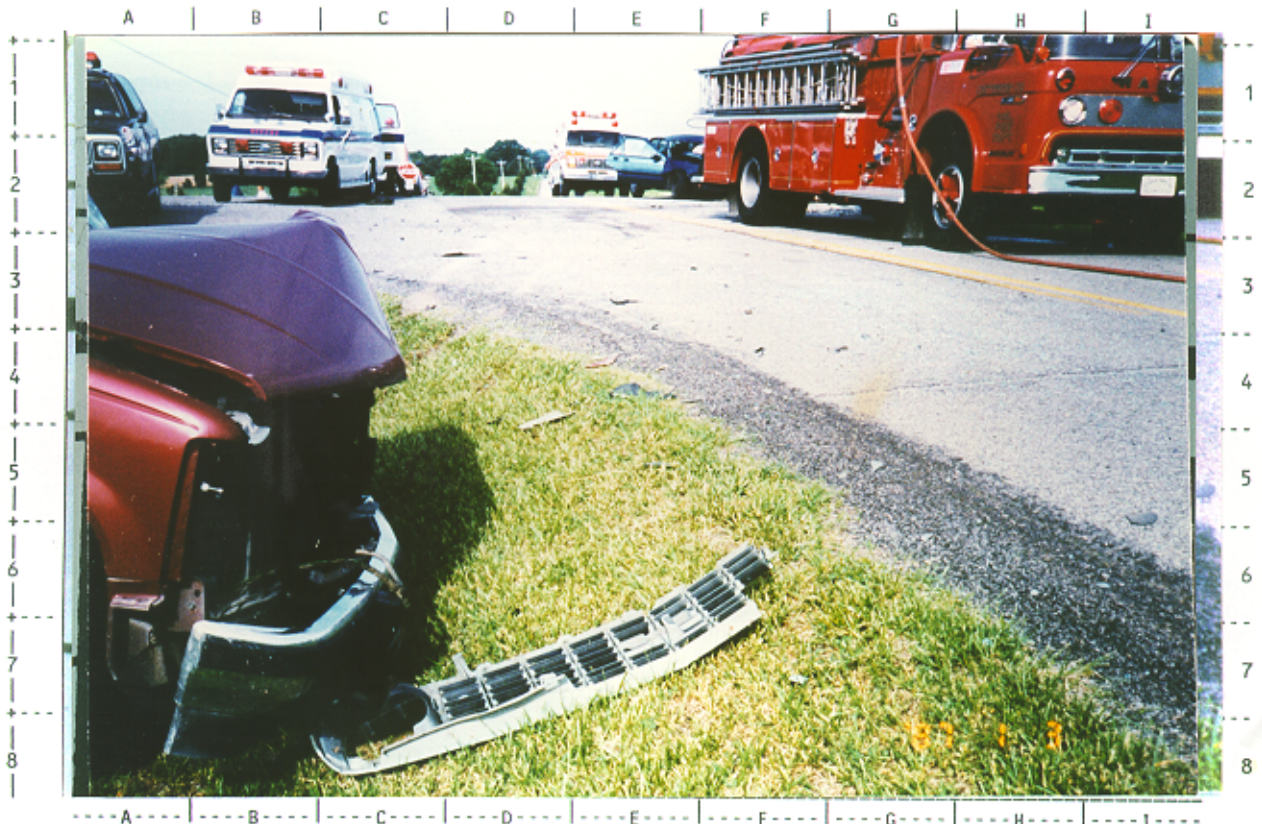
26 -- On-scene westward view of front of 1988 Chevrolet pickup at FRP; NOTE: 1991 Chevrolet Corsica's FRP (see cells E1--F1)

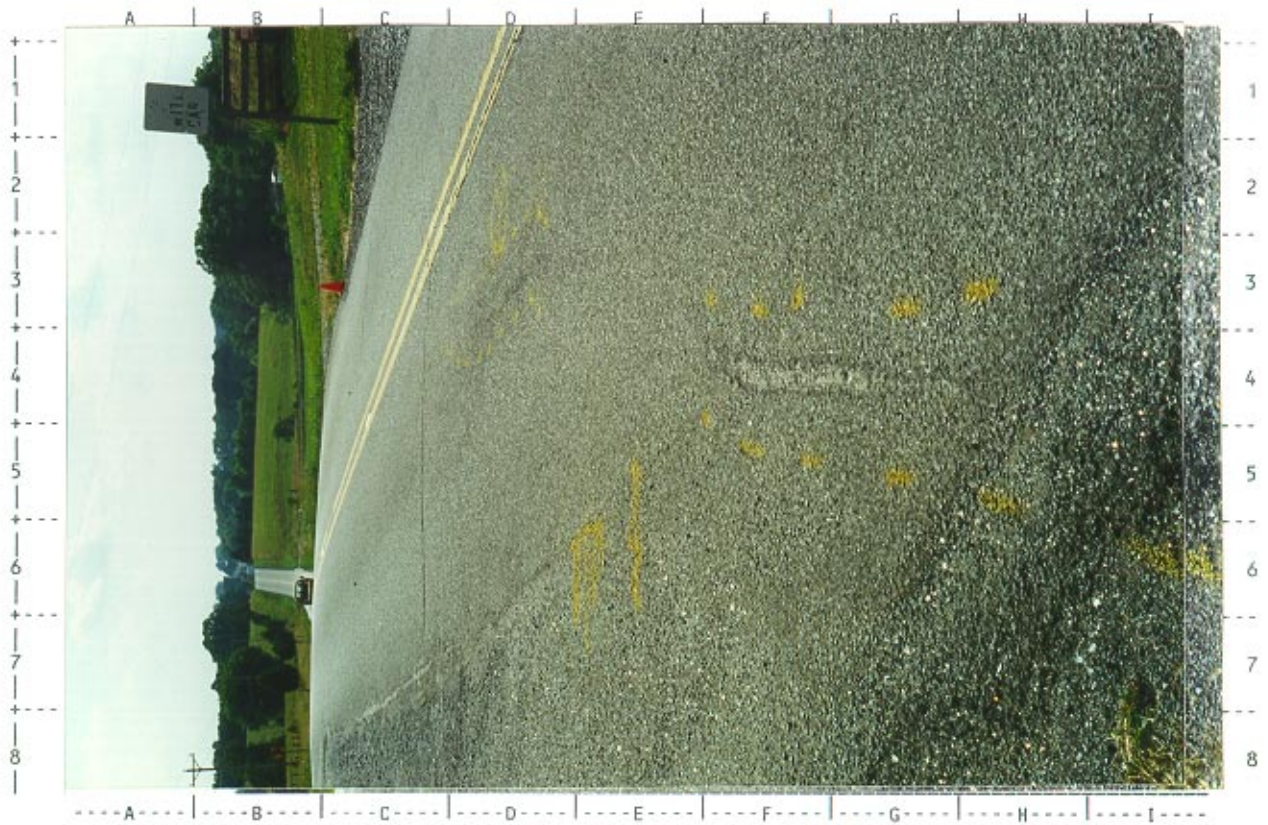
27 -- Westward view of 1988 Chevrolet pickup's LF gouge marks, POI, hillcrest, & curve; NOTE: Corsica's FRP marked by orange cone

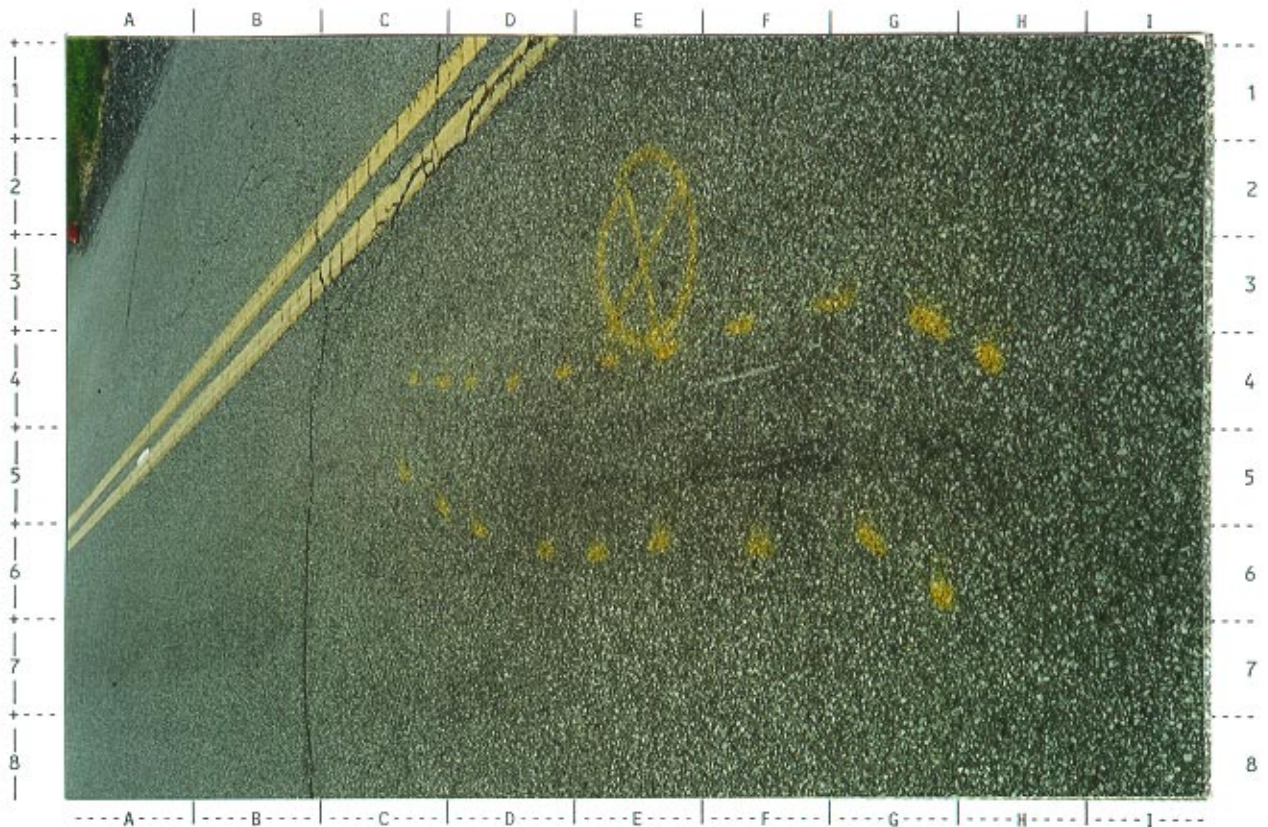
28 -- Westward close-up of 1988 Chevrolet pickup's LF skidmark, POI, and point of deflection

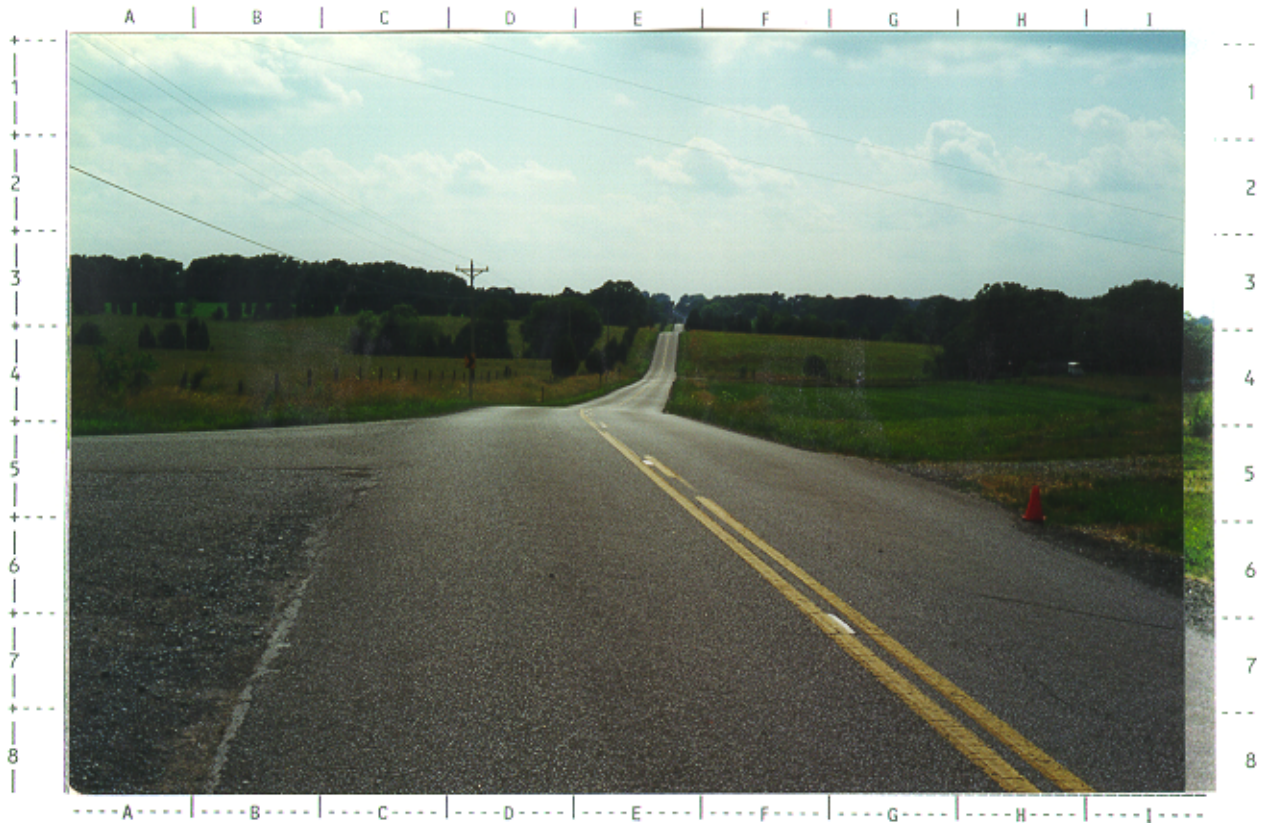
29 -- Looking back (westward) at 1988 Chevrolet C-1500 pickup's path of travel from POI; NOTE: orange cone marks FRP of Corsica

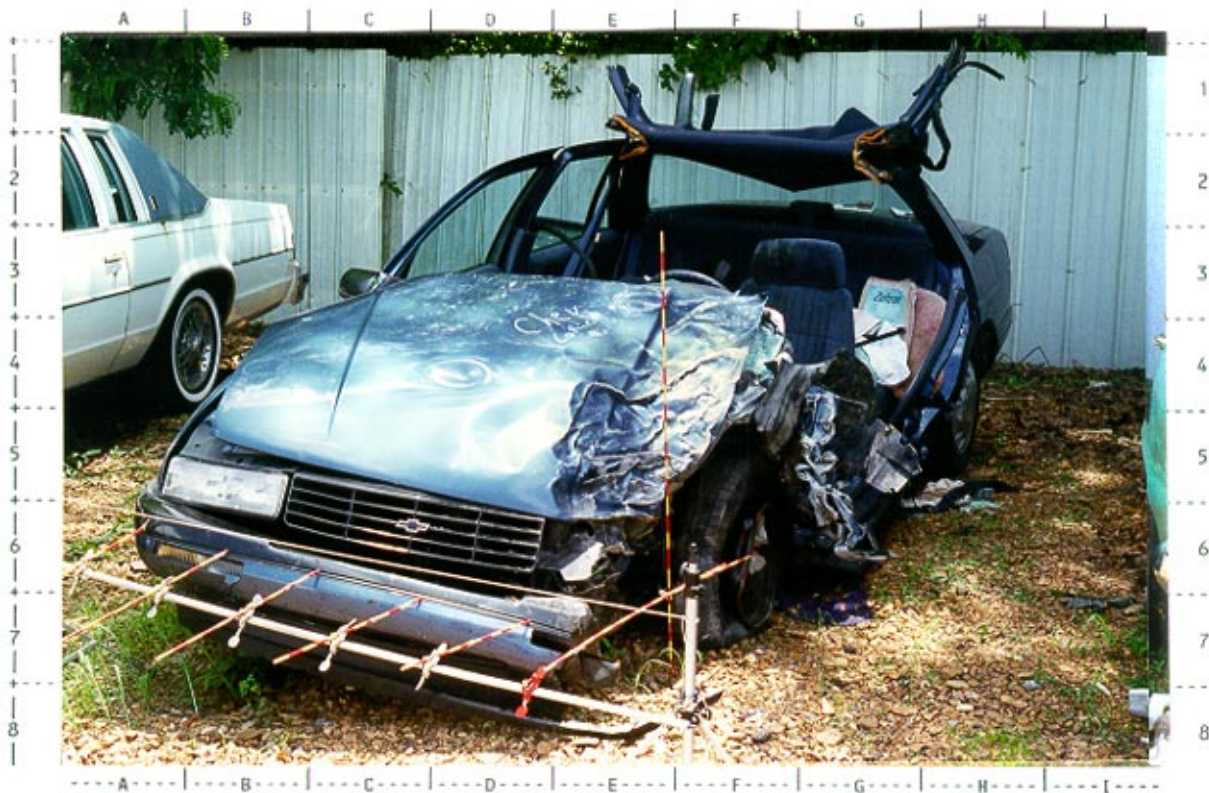
30 -- Frontal view of 1991 Chevrolet Corsica's front left damage with contour gauge present

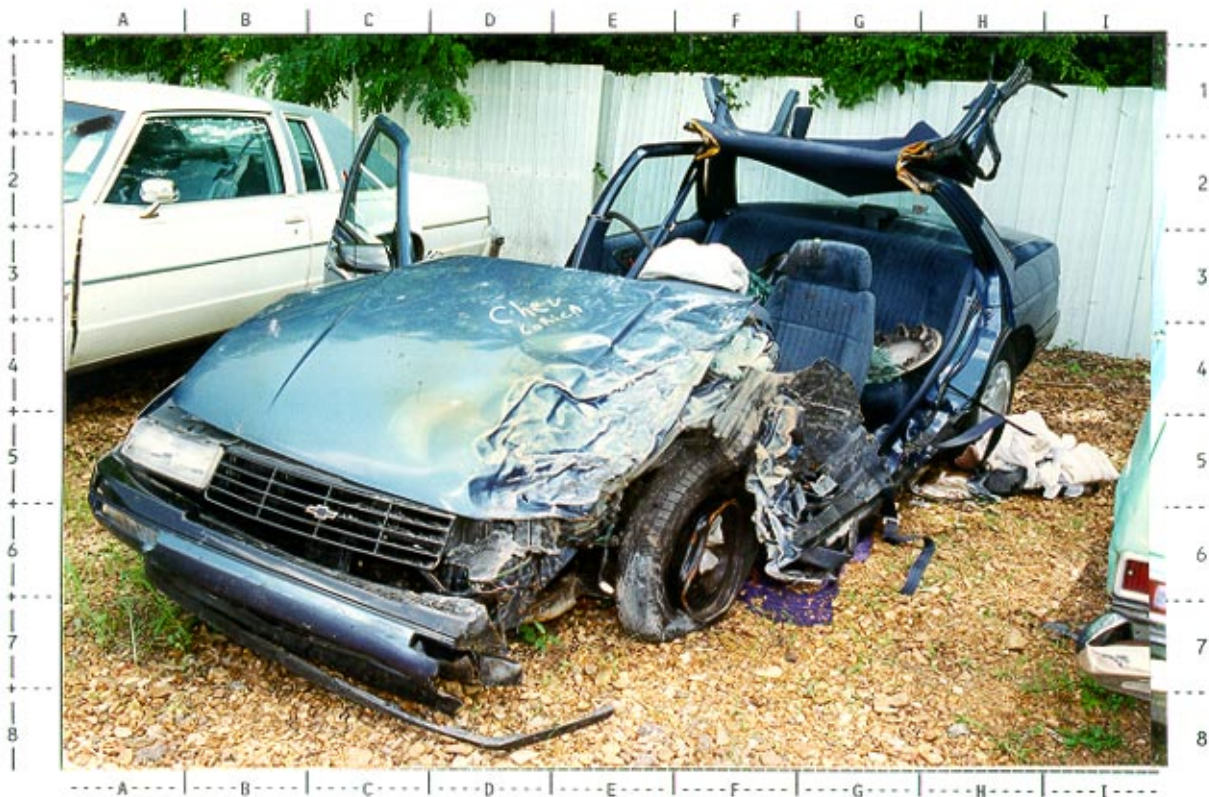
31 -- Front left view of 1991 Corsica's front left damage with contour gauge present; NOTE: peeled-back roof and cut L A- & B-pillars

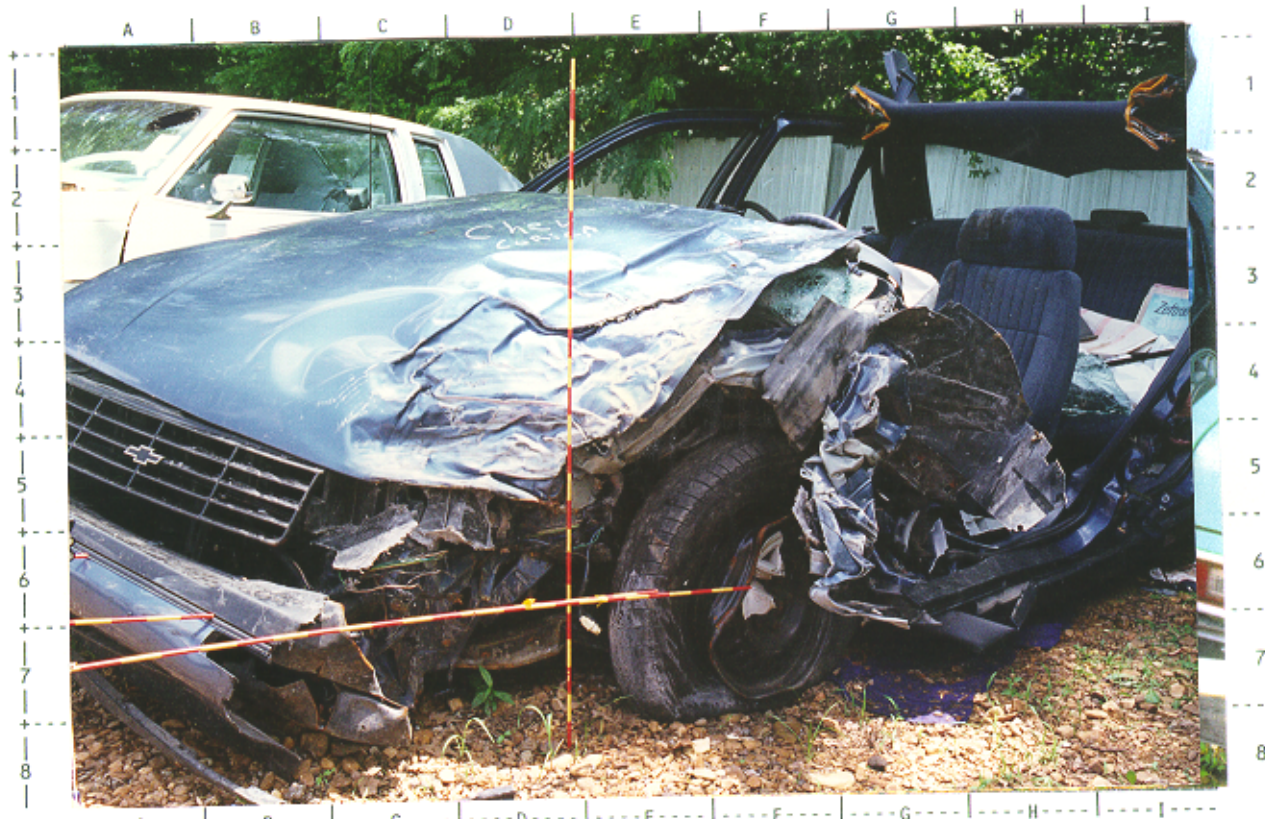
32 -- Front left (45 degree angle) view of 1991 Corsica's front left damage without contour gauge present; NOTE: roof & cut pillars

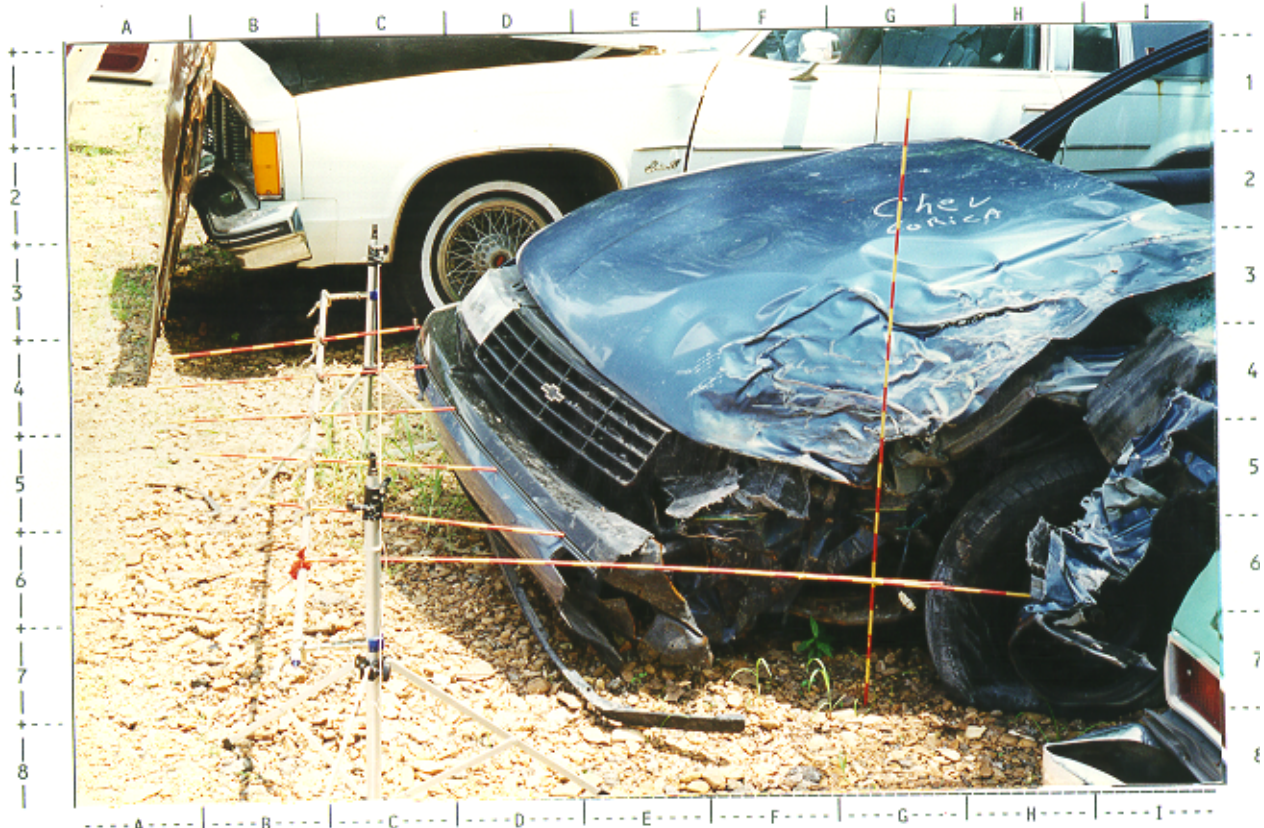
33 -- Front left (45 degree angle) view of direct damage to 1991 Chevrolet Corsica; NOTE: peeled-back roof and cut L A- & B-pillars

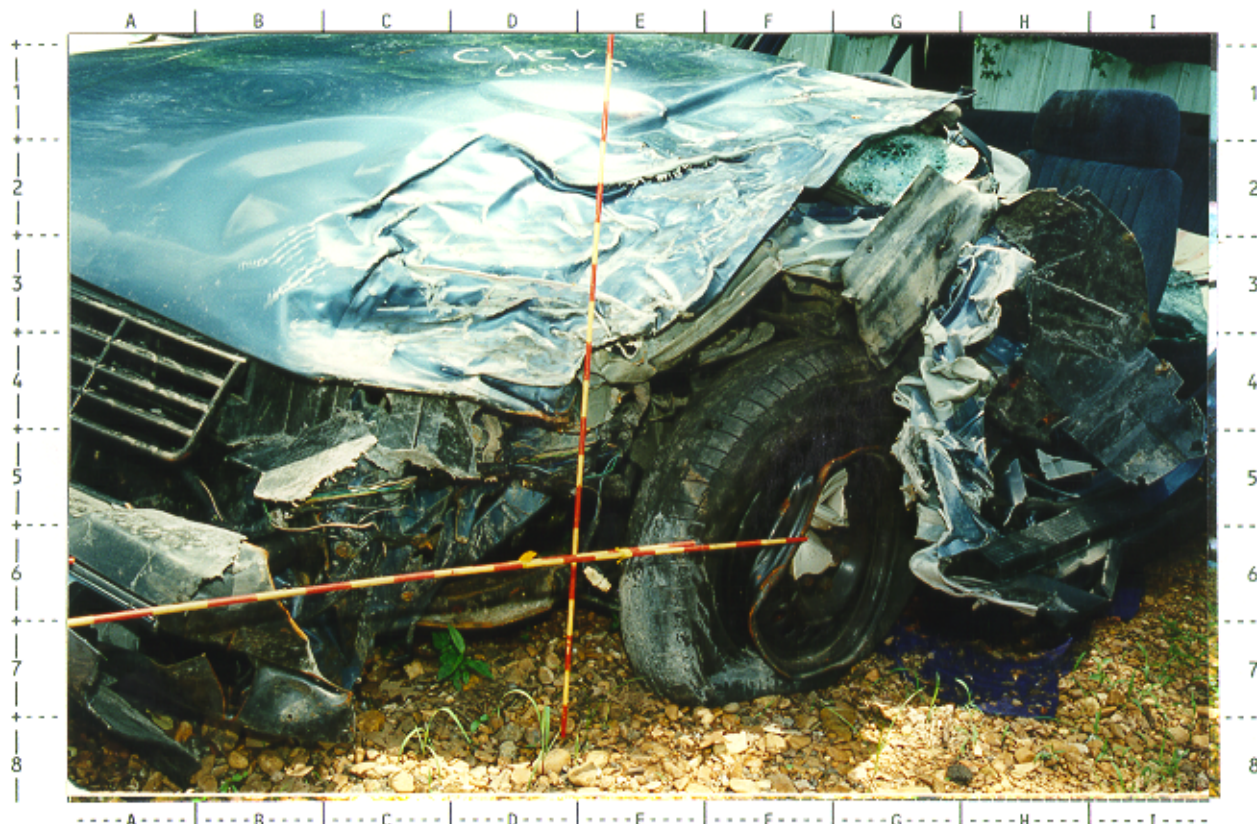
37 -- Bumper level view along 1991 Chevrolet Corsica's left side showing extensive FL corner damage, maximum crush, & reference rod

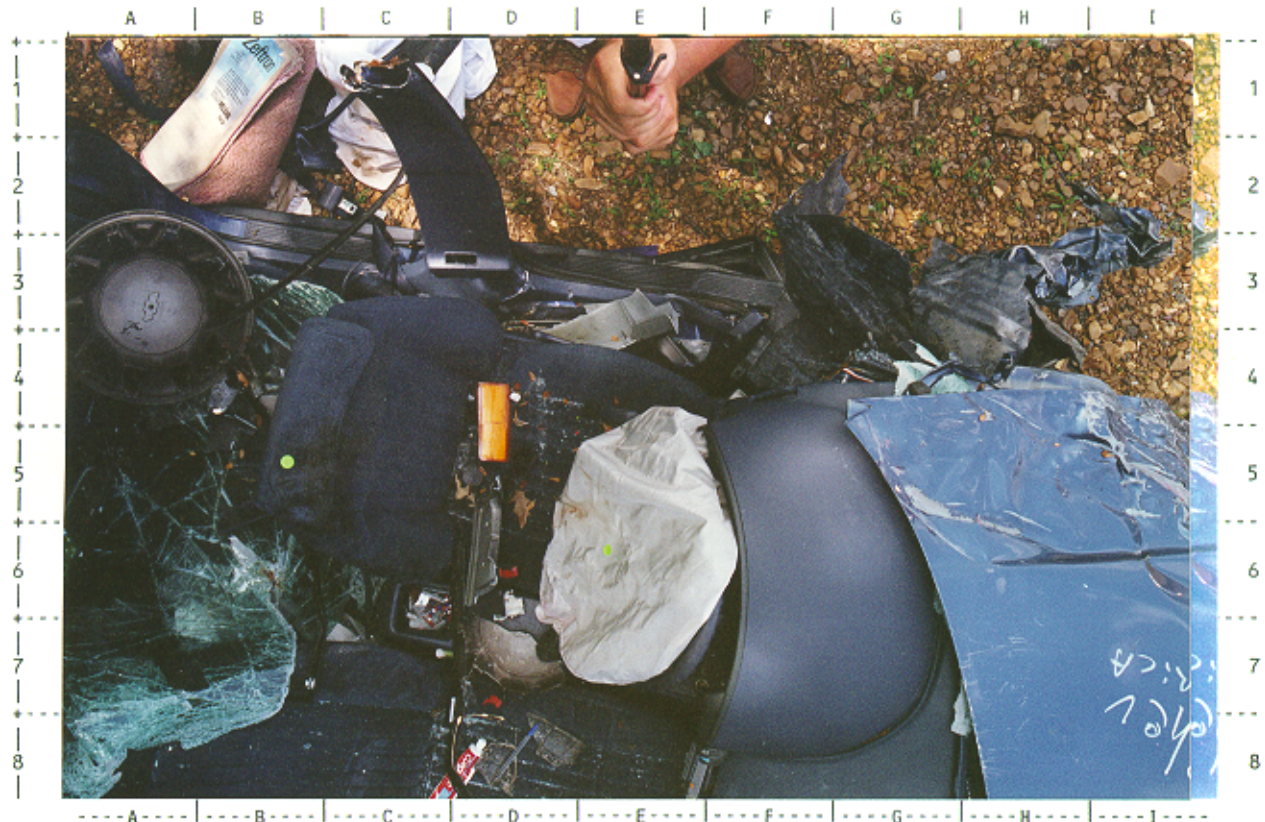
40 -- Overhead left center view of 1991 Chevrolet Corsica's driver area; NOTE: deployed air bag & roof peeled-back for extraction

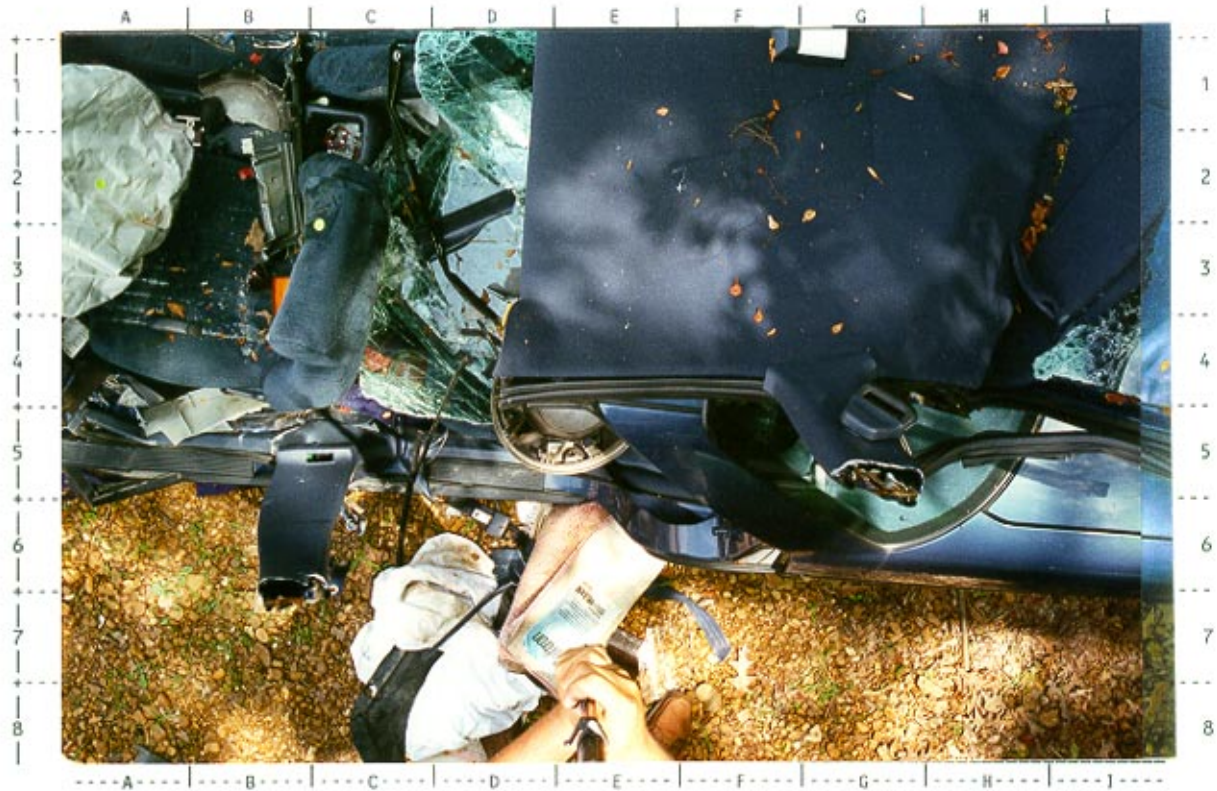
41 -- Overhead left center view of interior surface of 1991 Chevrolet Corsica's peeled-back roof; NOTE: no visible contact evidence

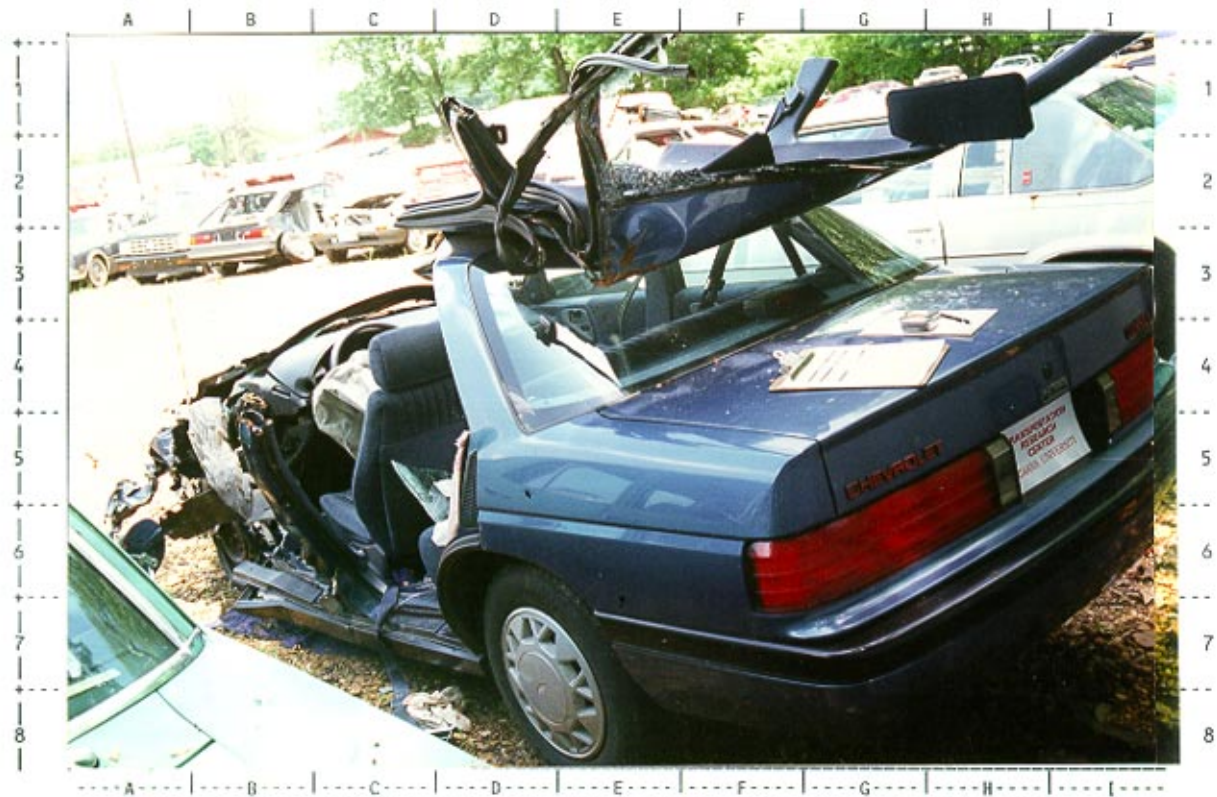
42 -- Left back (45 degree angle) view of '91 Chevrolet Corsica; NOTE: direct contact to left A-pillar and roof corner (cells D1--E3)

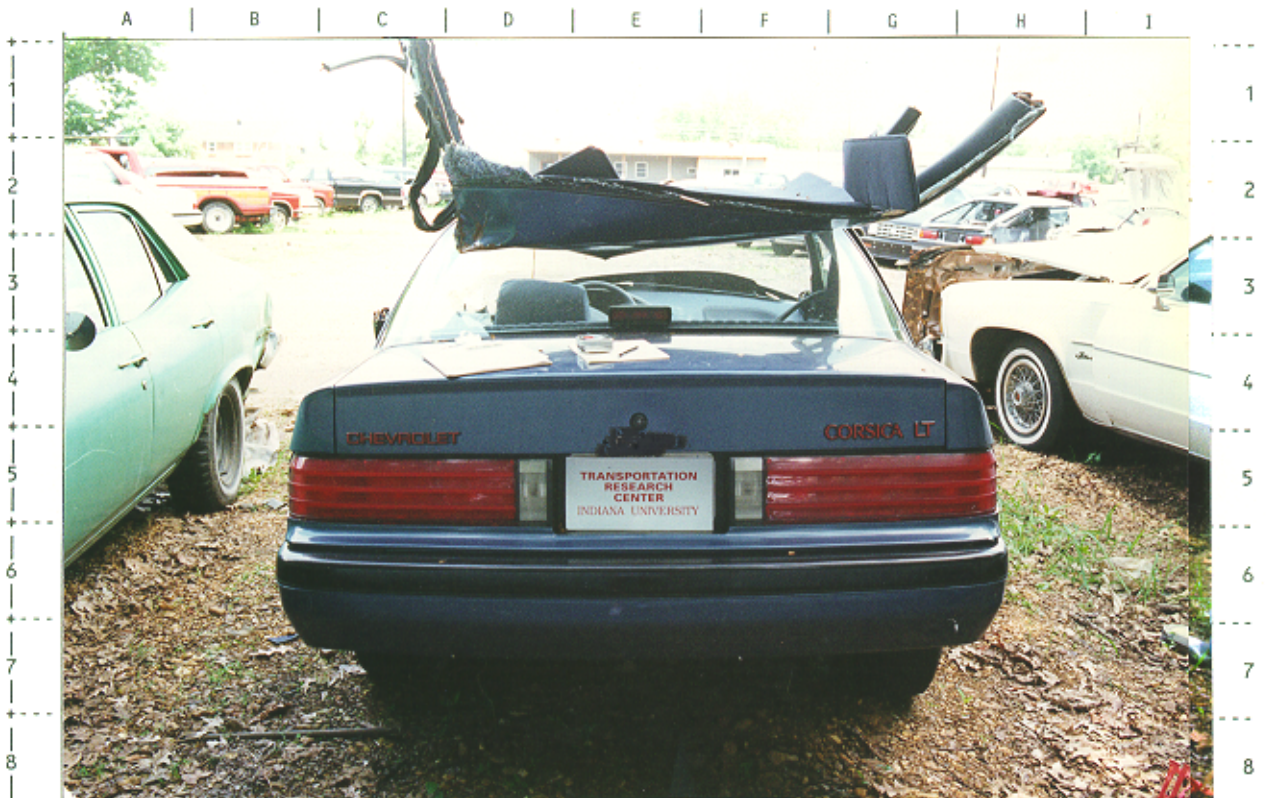
43 -- Close-up of direct damage to '91 Chevrolet Corsica's left A-pillar and roof corner--viewed from back

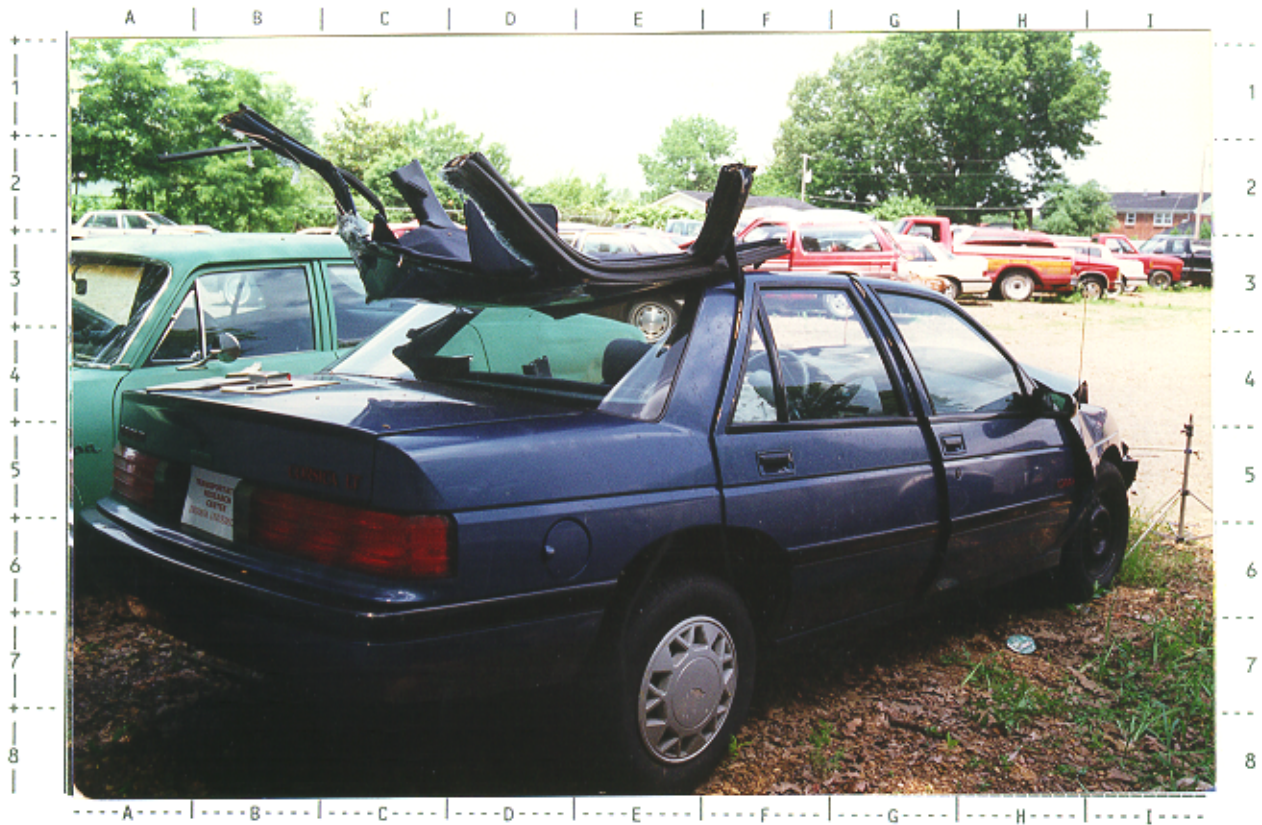
44 -- Back view of 1991 Chevrolet Corsica's undamaged back

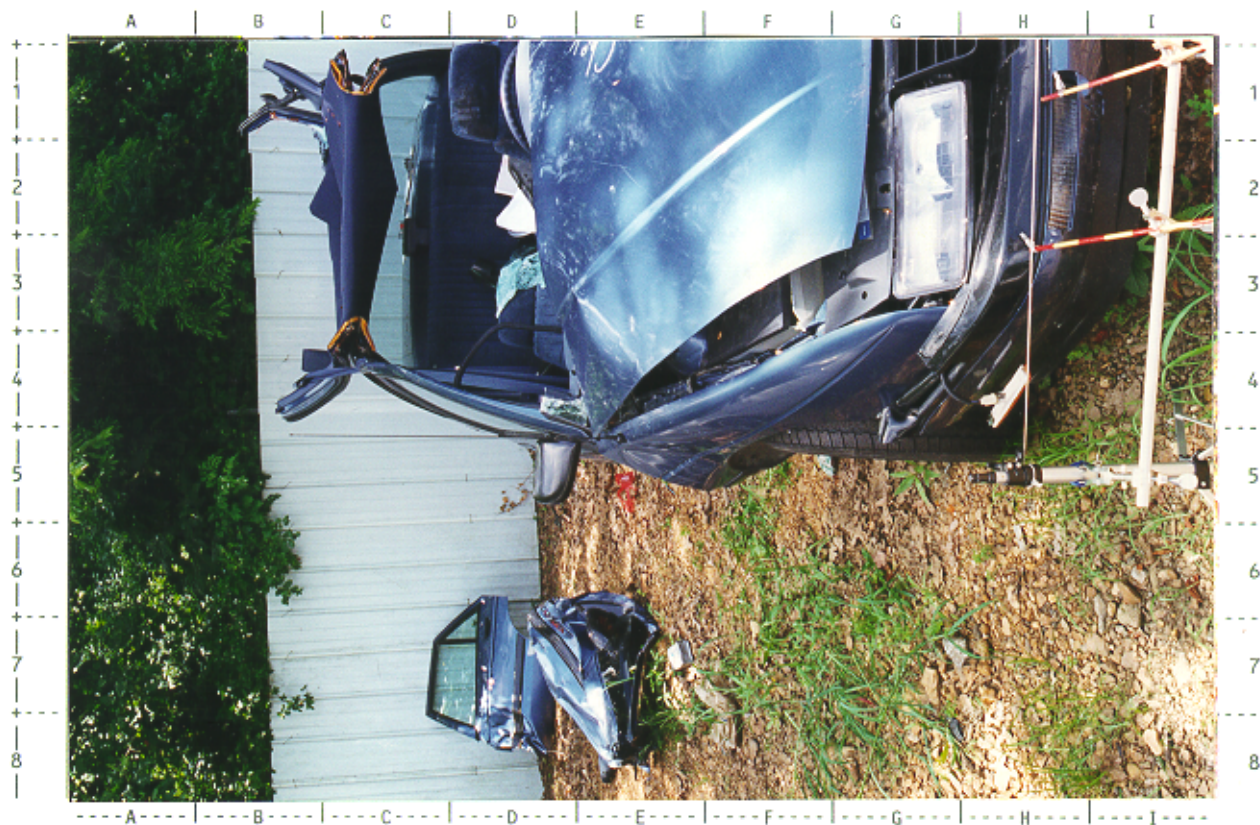
46 -- Front right view of frontal and extensive front left damage to 1991 Corsica; NOTE: peeled-back roof and undamaged RF A-pillar

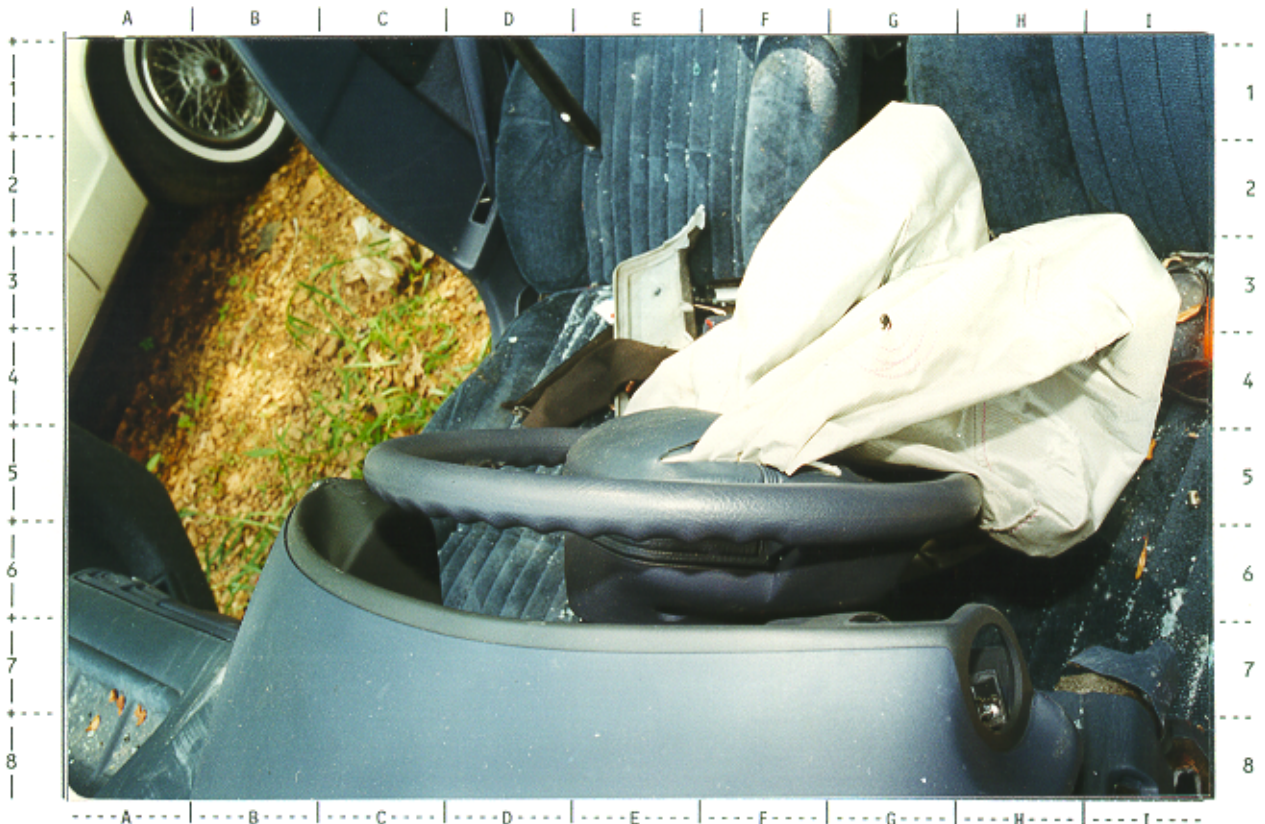
52 -- Overhead left center view of 1991 Chevrolet Corsica's undeformed steering wheel and deployed air bag

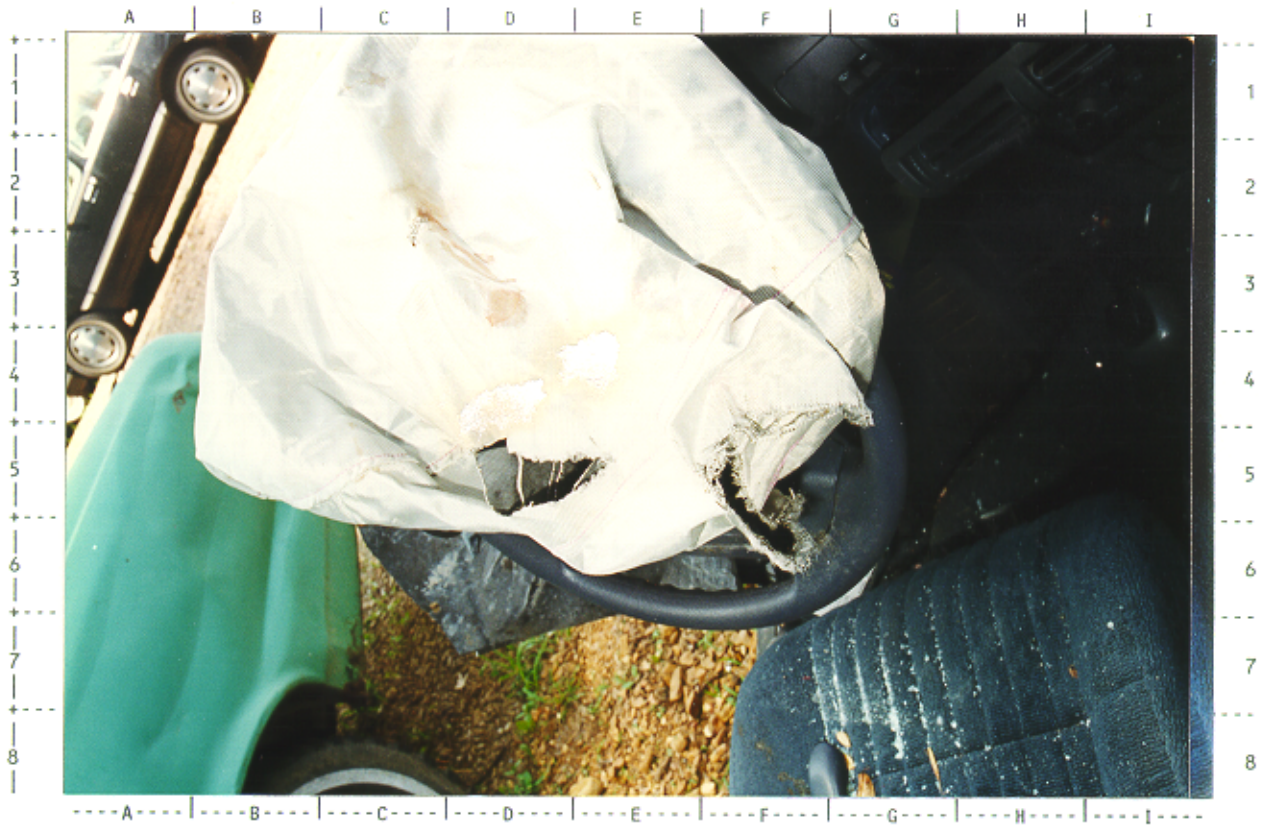
55 -- Close-up of underside tears in '91 Corsica's driver air bag most likely from L doors being placed in front seat during towing

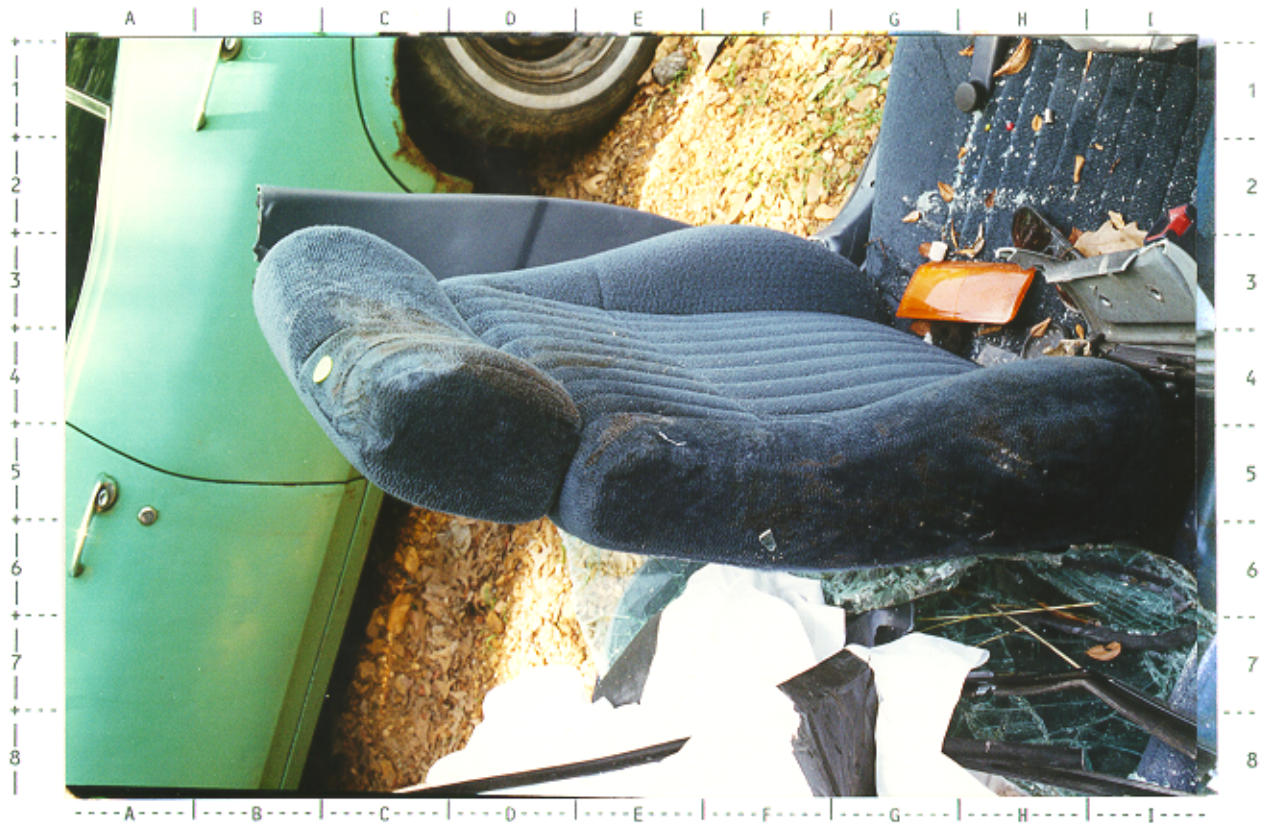
58 -- Overhead left front view of blood stained left front (driver's) seat of 1991 Chevrolet Corsica; NOTE: cut left B-pillar

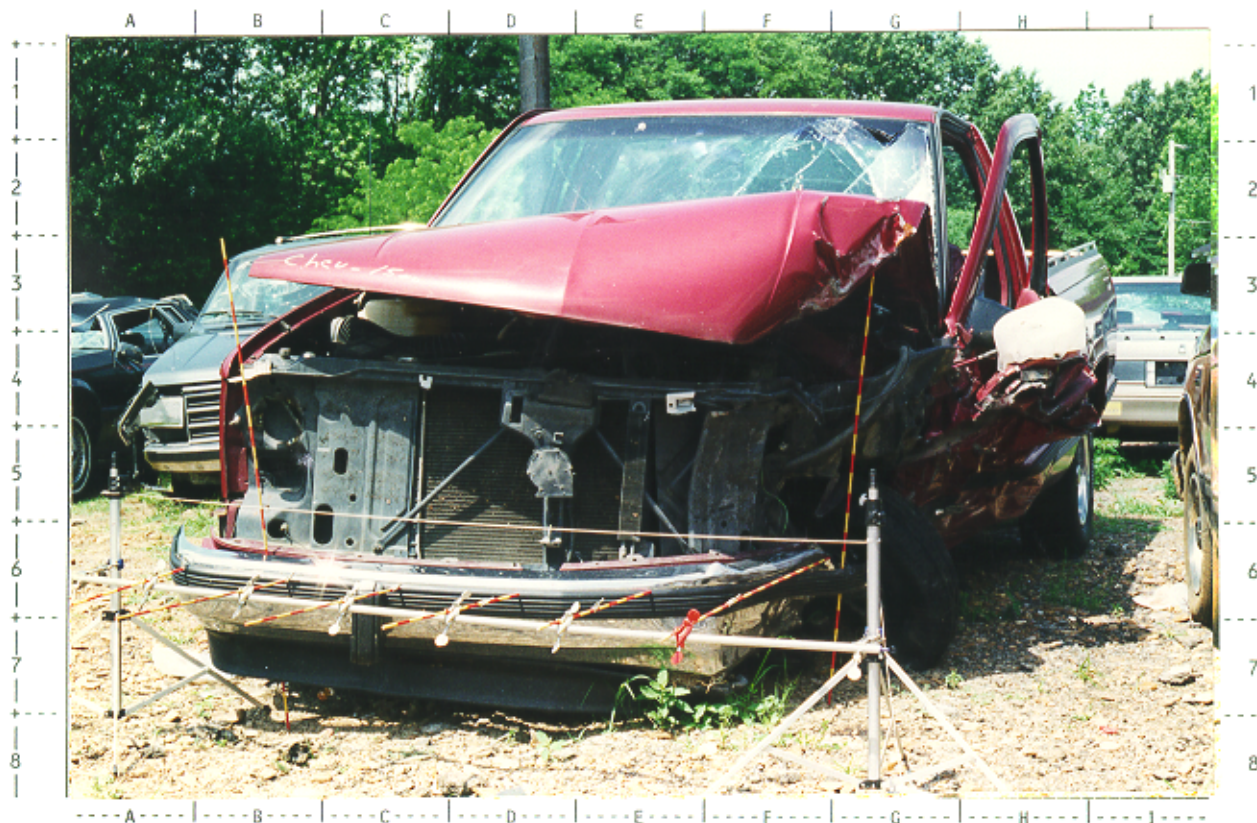
62 -- Frontal view of 1988 Chevrolet C-1500 pickup's front left damage with contour gauge present

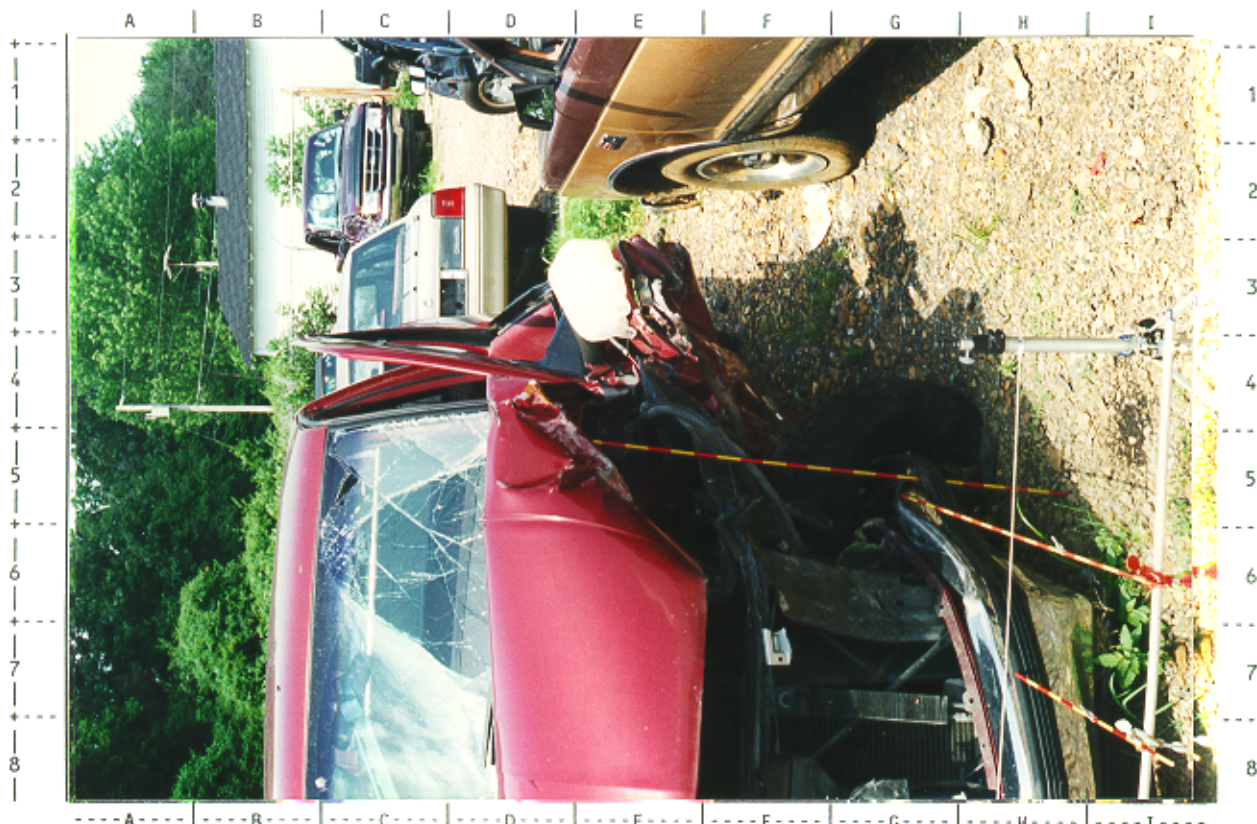
63 -- Front left view of '88 Chevrolet pickup's front left damage with contour gauge present; NOTE: FL hood damage and vertical rod

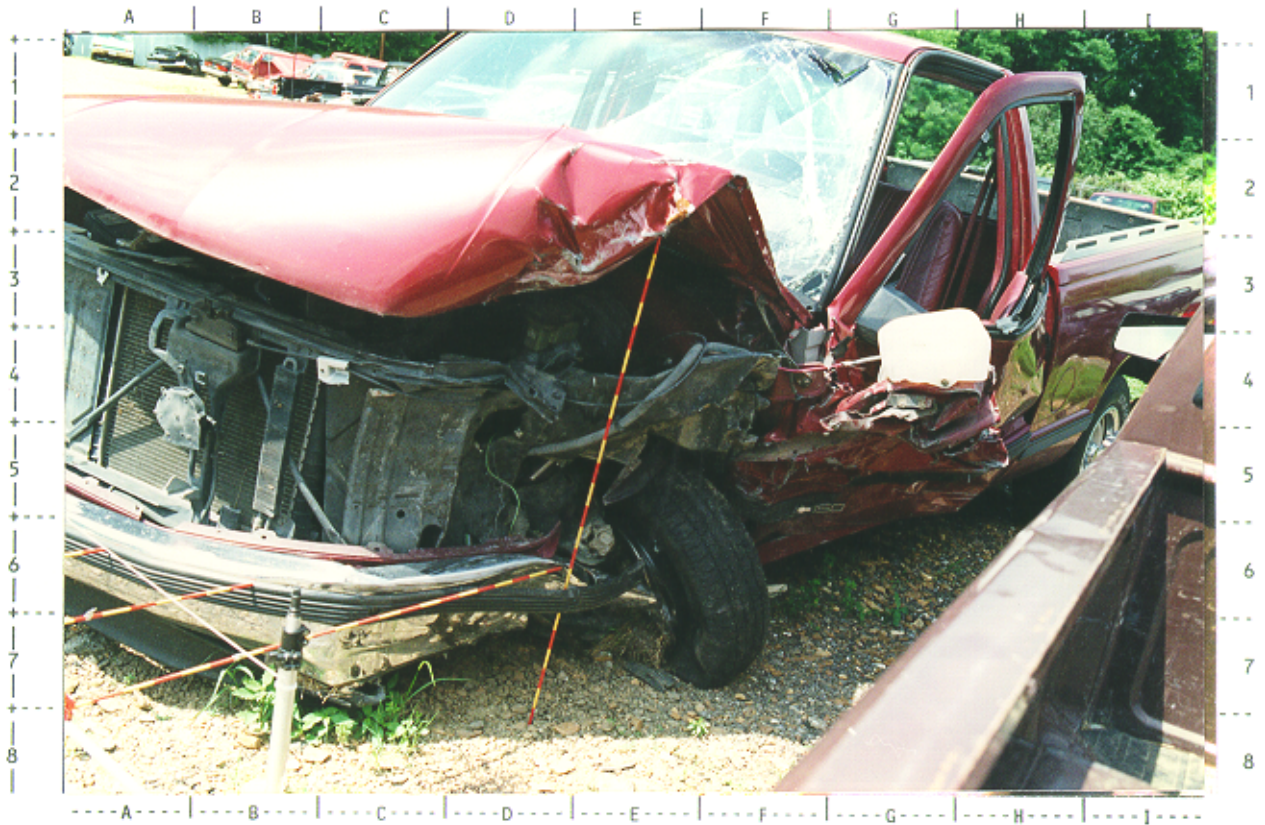
64 -- Left front reference line view showing frontal damage to 1988 Chevrolet C-1500 pickup; NOTE: vertical reference rod

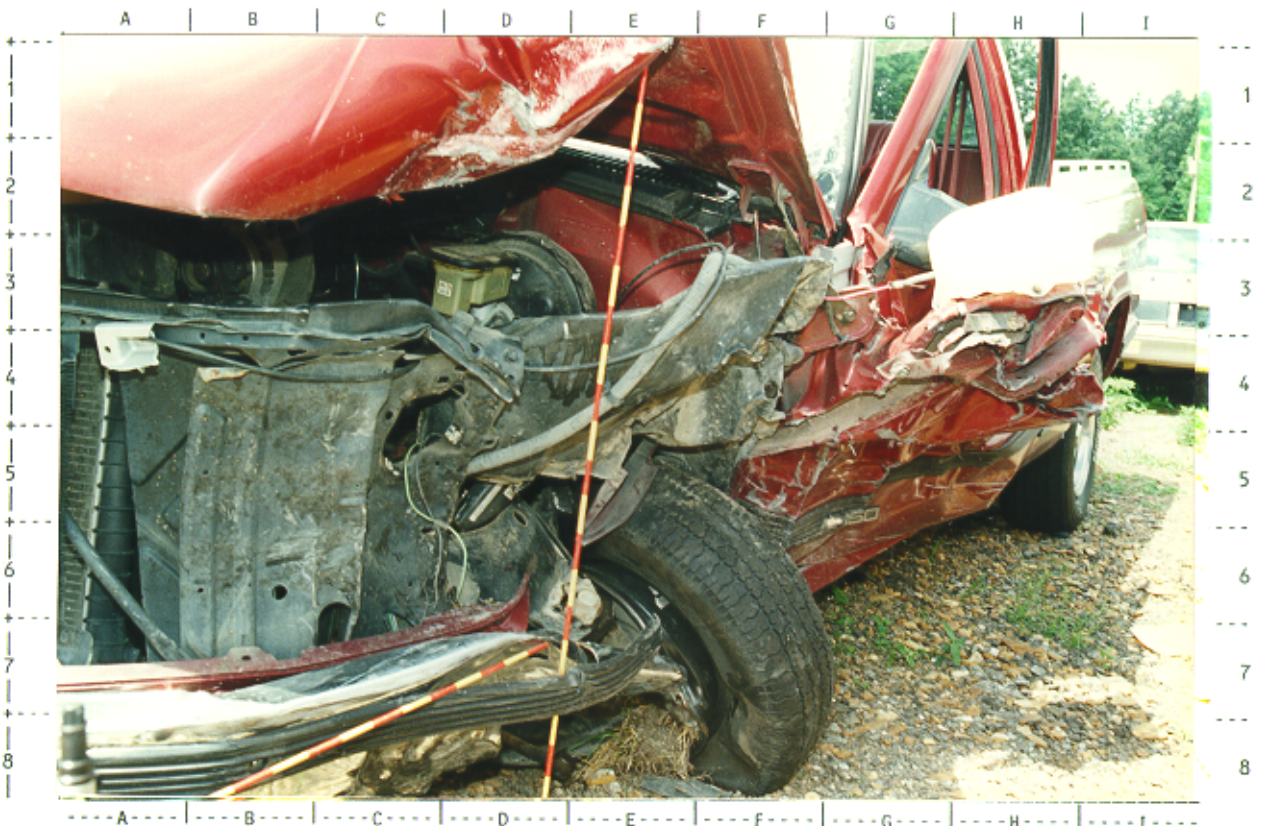
65 -- Front left view of damage to 1988 Chevrolet pickup; NOTE: hood damage (cells D2--E3) from contact with '91 Corsica's A-pillar
